Forensic Analysis of Failure of Shoring Piles

Forensic analysis of failure of shoring piles

N. Santosh Rao

Nagadi Consultants Private Limited, India

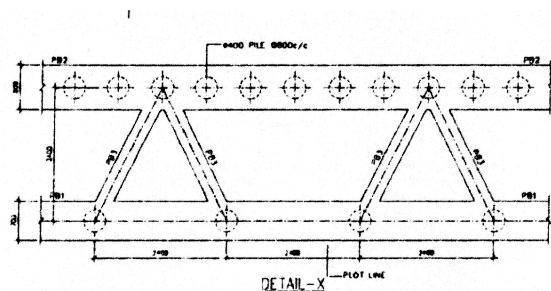
Fig. 1 Pattern of shoring piles

The shoring piles had been provided in a pattern as shown in fig.1. As per discussions held with the structural designers for the project, the front / facing row of shoring piles were provided for retaining the soil while the rear row of piles, lesser in number (i.e. one rear row pile for every 3 front row piles) were provided as anchors for the front row of piles with the anchoring ties provided at the top end of the piles in a triangular pattern as seen in the above figure. Capping beams had also been provided along the top of both the front and rear row of piles

Notably, the centre point of the collapsed portion of the shoring piles more or less lies at the break/shift in the continuous line of shoring pile system as indicated by the circle marked in fig. 1. This break/shift in the continuous line of the shoring pile system is critical in that any defect in the construction at this location can prevent the proper functioning of the shoring pile system as a two-dimensional system and instead make the shoring piles at this location act as free standing piles and consequently, cause a reduction in factor of safety against structural failure eventually leading to the structural failure of the piles at this location.

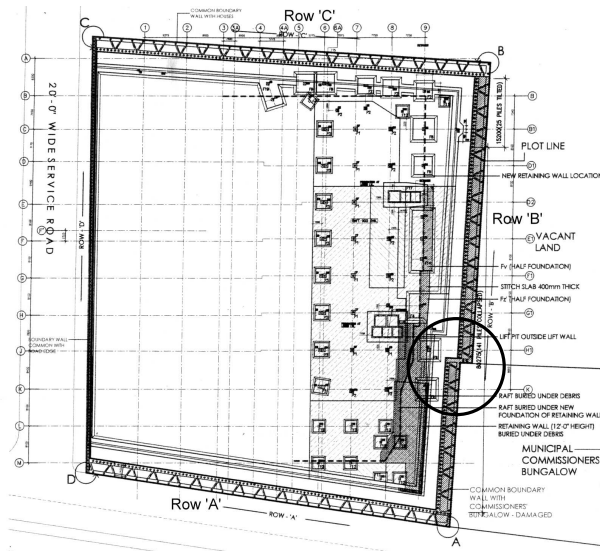
Fig. 2 Schematic site layout

The shoring piles along the site boundary in which the collapse occurred (i.e. row B; marked by shading in fig. 2) had been constructed by drilling the pile bores using the traditional DMC (i.e. drilling mud circulation) method and temporary liner/casing of about 6 to 8m length had been used during the drilling.

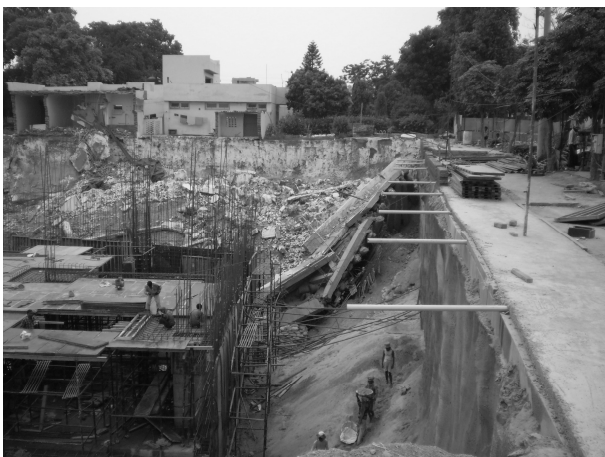
Fig. 5 Front view of shoring piles post failure

- b. The failure surface in the soil behind the line of shoring piles is only a few metres distance from the line of shoring piles and is almost vertical in the upper portion as seen from the photograph in fig. 4.
- c. Other views of the collapsed area very clearly show the bent and broken piles in photographs in figs. 5 & 6. The orientation of the bent piles indicates that the bent portion of the piles is only a few metres in length.
- d. The guniting adopted in the upper part and the sand bags provided in the lower part for preventing the soil behind the shoring piles from flowing out can be seen in the background in the photograph in fig. 4.

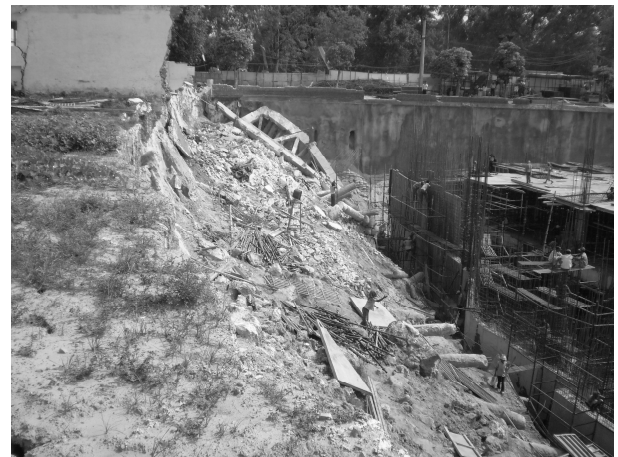
Fig. 6 Another view of post failure conditions
